RESULTS REPORT:

FACILITY LIGHTING — WINTER

WAYNE N. ASPINALL FEDERAL BUILDING
GRAND JUNCTION, COLORADO

Lighting Research Center
Rensselaer Polytechnic Institute

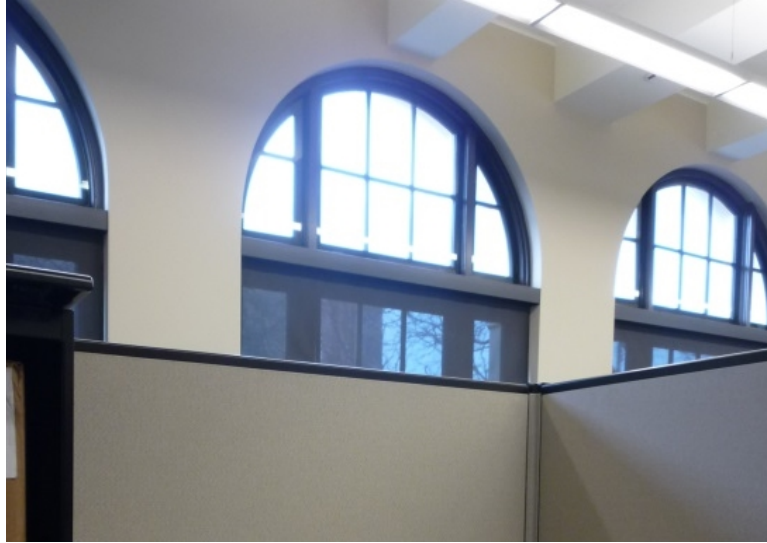
Window shades were not in use on the north-facing windows on the first floor. Several of the west-facing windows did have black mesh shades pulled down, as shown in Figure 2.

Figure 2. West-facing windows are fitted with black mesh shades.

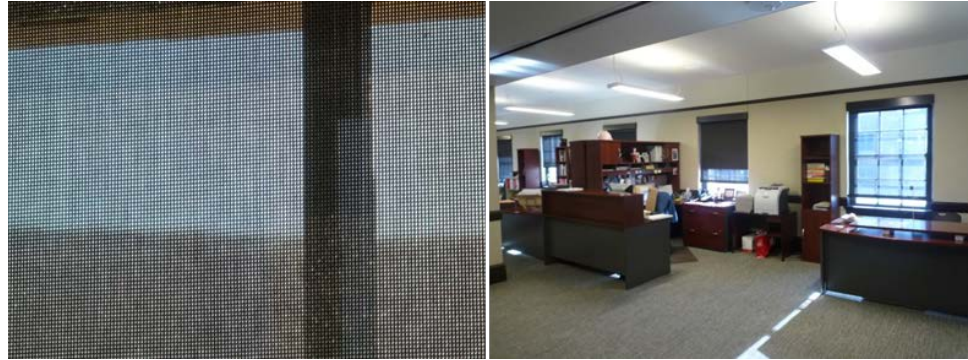
For these south-facing windows, personnel have the option of using the (translucent) black mesh shades, as well as opaque blackout shades (Figure 4). Electric lighting appears to be the same fluorescent pendants as on the first floor. As shown in Appendix D, one sensor sends a signal to all the luminaires in the space; although the right window in Figure 4b has blackout shades retracted, subsequent sun may not be “seen” by the sensor.

Figure 4. (A) A close-up of the translucent black mesh shades personnel with south-facing windows have the option to use. (B) Although one window has blackout shades retracted, the sun may not be “seen” by the photosensors in the room.

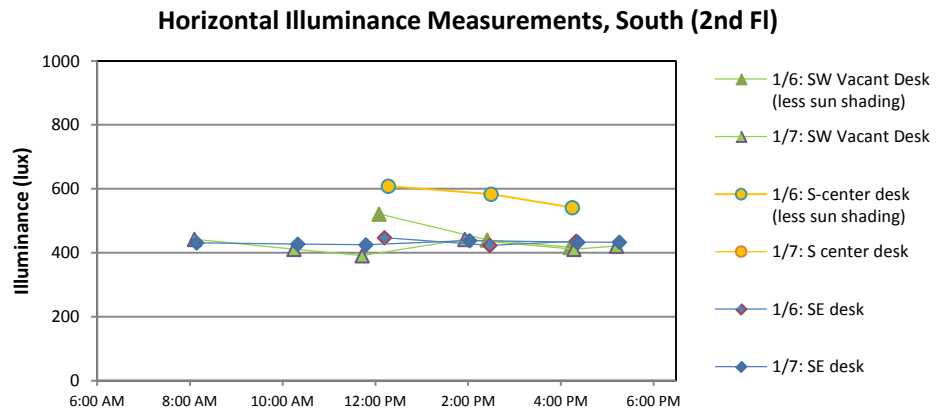
Employees with south-facing windows tend to use shades. At many desks, illuminance measurements did not vary substantially between the sunny day and the cloudy day. Because measurements were similar after dark, early in the morning, and throughout the day, it is assumed that there was little contribution from daylight at the measurement points shown above for this southern exposure. Data from other devices indicate that during this monitoring period, the lights in this space were not dimming in response to daylight. It is possible that the use of shades not only limited illuminances at the desks, but also at the photosensor on the ceiling, which may explain why it did not dim down the lights.

As shown in Appendix A and Figure 6 below, illuminances on the desk (horizontal) at these measurement points were around 400 lux (40 fc); vertical illuminances were around 200 lux (20 fc). The person working at the center desk chose to open his blackout shades on the overcast day (1/7/14), thus measurements at his desk were higher than at the southeast (SE) desk. The southwest (SW) desk was vacant, so only mesh shades were used, not blackout shades.

Figure 6. Horizontal illuminance measurements on the southern exposure (second floor).

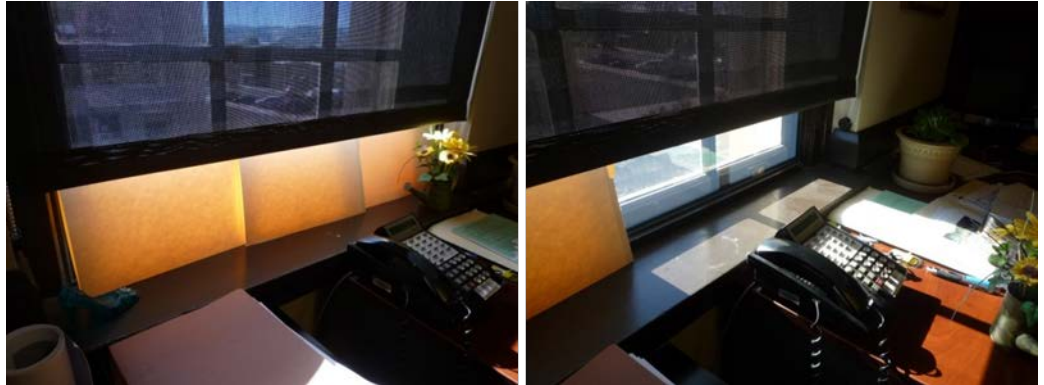
The occupant at the SE desk pointed out that the mesh shades in the second floor south windows are not long enough to fully cover the window. In the summer, the sun is high in the sky and does not fall on the desk surface. But in the winter, the occupant uses office supplies to cleverly shield the sun; see Figure 7. The adjacent (center) office did

not employ this shading technique, thus showed higher illuminances even on the sunny day when the blackout shade was down.

Figure 7. (A, left) As the mesh shades on this second floor south window are not long enough to fully cover the window, the occupant of this desk uses office supplies to shield the sun in the winter. (B, right) The sun hits the desk through the gap between the shade and window when the window is not covered.

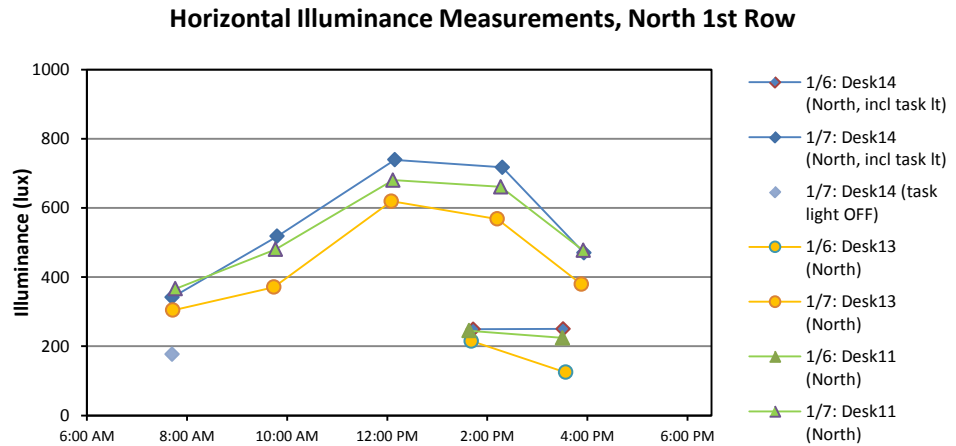
As shown in Appendix B and Figure 8 below, for the first row of desks on the north side of the building on the first floor, illuminances on the desk (horizontal) were lower on the sunny afternoon (e.g., 125-245 lux on 1/6/14) than on the cloudy afternoon (e.g., 304-680 lux on 1/7/14). Other data (see page 14) indicate that the electric lights were operating at low output on the sunny day, and were at full output on the cloudy measurement day. The lighting control system may need to be adjusted so that light levels on the desks are not lower on sunny days than cloudy days or after dark (target illuminance was not listed in the documentation). Typically target illuminance would be between 30-50 fc (300-500 lux on the work plane). The minimum amount of light during the day should be no less than the electric light only after dark. In general, given that this is a daylit space, the amount of light during the day is not likely to be lower than at night. However, reducing the aggressiveness of dimming will translate to less energy savings.

On the north second row desks, horizontal illuminances were low [40-220 lux (4-20 fc)] throughout the measurement day. It should be noted that these second row desks do not have electric lighting overhead due to a large skylight that does not receive direct sun due to its location behind the protruding second and third floors. Vertical illuminances were equivalently low [30-170 lux (3-16 fc)]. If these desks eventually become occupied, task lighting will be necessary and energy use will increase (though not necessarily to a substantial extent).

Figure 8. Horizontal illuminance measurements on the north desks, first row.

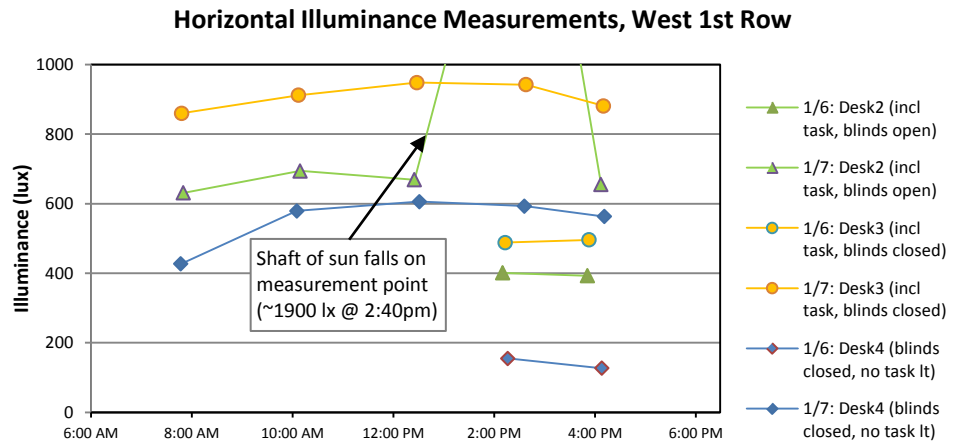
As shown in Appendix C and Figure 9 below, on the first row of the west side, horizontal illuminances started at about 400-550 lux in the morning (not including contribution from a task light). Keeping mesh shades open and use of task lights increased both horizontal and vertical illuminances. One desk had shades open, and the two others had shades closed. On the sunny afternoon, horizontal illuminances were actually about half the values of the cloudy afternoon. This may be due to the fact that the overhead lighting was dimmed to low output on the sunny day, but was operated at full output on the cloudy day (see page 6). As discussed above, the lighting control system may need to be adjusted to be less aggressive, which would translate to less energy savings.

Figure 9. Horizontal illuminance measurements in the west, first row of desks.

In the second row of the west side, horizontal illuminances were about 450-550 lux throughout the day at all three desks. Measurements on the sunny day were lower than the cloudy day for both horizontal and vertical measurements. As this space has tall ceilings (greater than 12 ft.), these desks may be receiving light from the row of lights close to the windows, which are aggressively dimming in response to daylight.

Alternatively, the second row of lights (directly above this row of desks) may possibly be included in the lighting control zone closest to the west windows, and may be dimming in response to daylight; if so, these lights should be removed from photosensor operation.

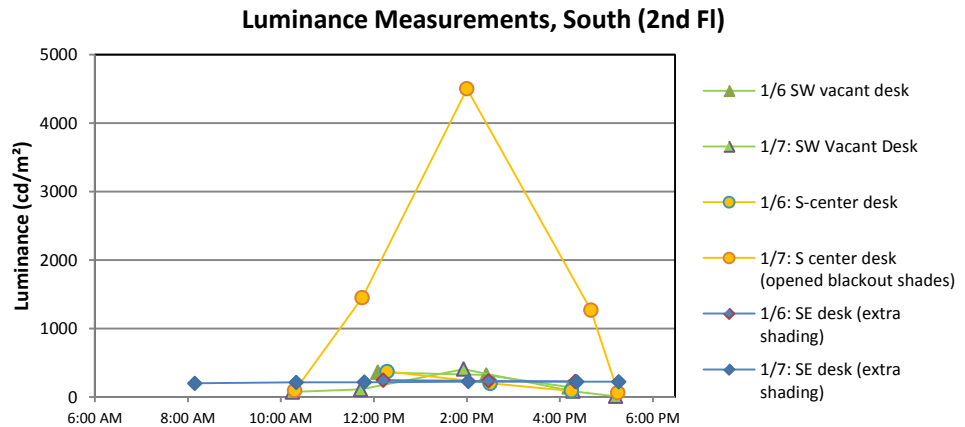
As shown in Appendix A and Figure 10 below, luminance measurements from the south desk seating positions show the impact of window treatments and furniture arrangements. When the person at the center desk opened his blackout shades after the 10 a.m. measurement, subsequent luminance measurements were higher than the sunny day despite the cloudy skies; on the sunny day his blackout shades were down, so luminances were lower.

Seating orientation also affects view of potentially glaring windows. The vacant desk is facing away from the window, while the seats at the center and SE desks are oriented perpendicular to the window. Furniture placement is an important consideration when it comes to maximizing light on the desk and minimizing direct or reflected glare. LRC recommends placing computer screens perpendicular to windows to minimize glaring reflected images from windows in shiny surfaces such as computer monitors (“veiling reflections”). Veiling reflections undermine the user's ability to see their work on the computer monitor.

Figure 10. Luminance measurements on the south desks, second floor.

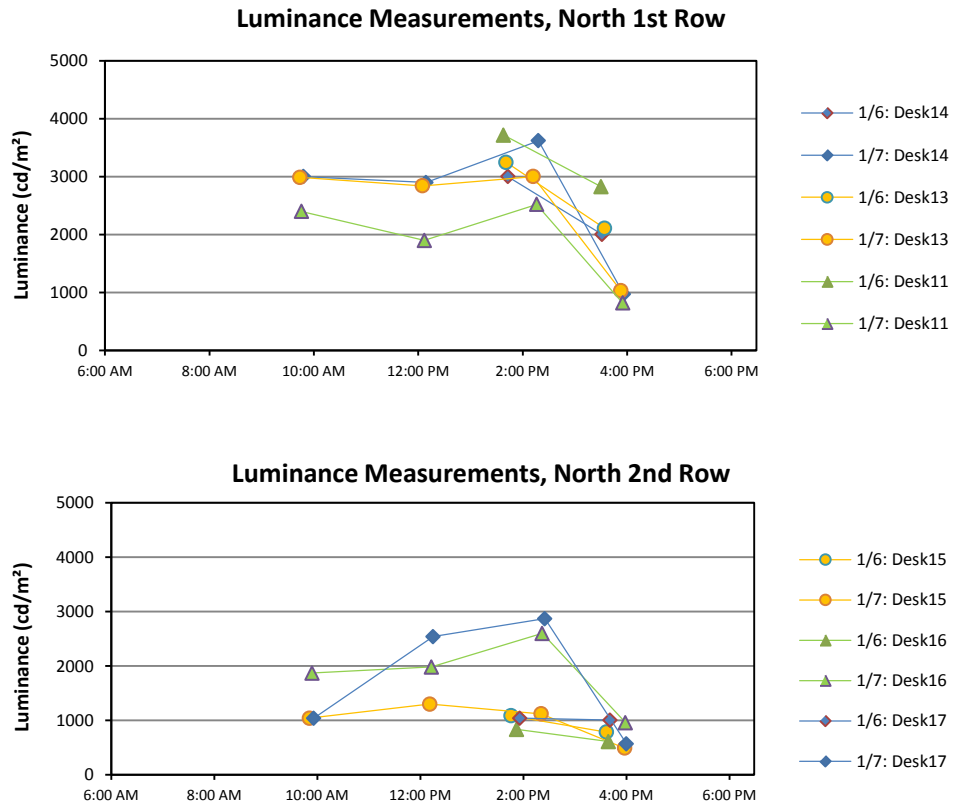
For windows on the north side of the building, there are no window treatments. This is common since in the northern hemisphere, the sun rarely shines on the north side of buildings, and not during normal business hours. As shown in Appendix B and Figure 11 below, luminances viewed from the north desks (without shades) were higher than those measured at the south desks (with shades). Seats in the first row of the north side face away from the windows and face diagonally towards the window in the second row.

Figure 11. (A, top) Luminance measurements: north desks, first row. (B, bottom) Luminance measurements: north desks, second row.

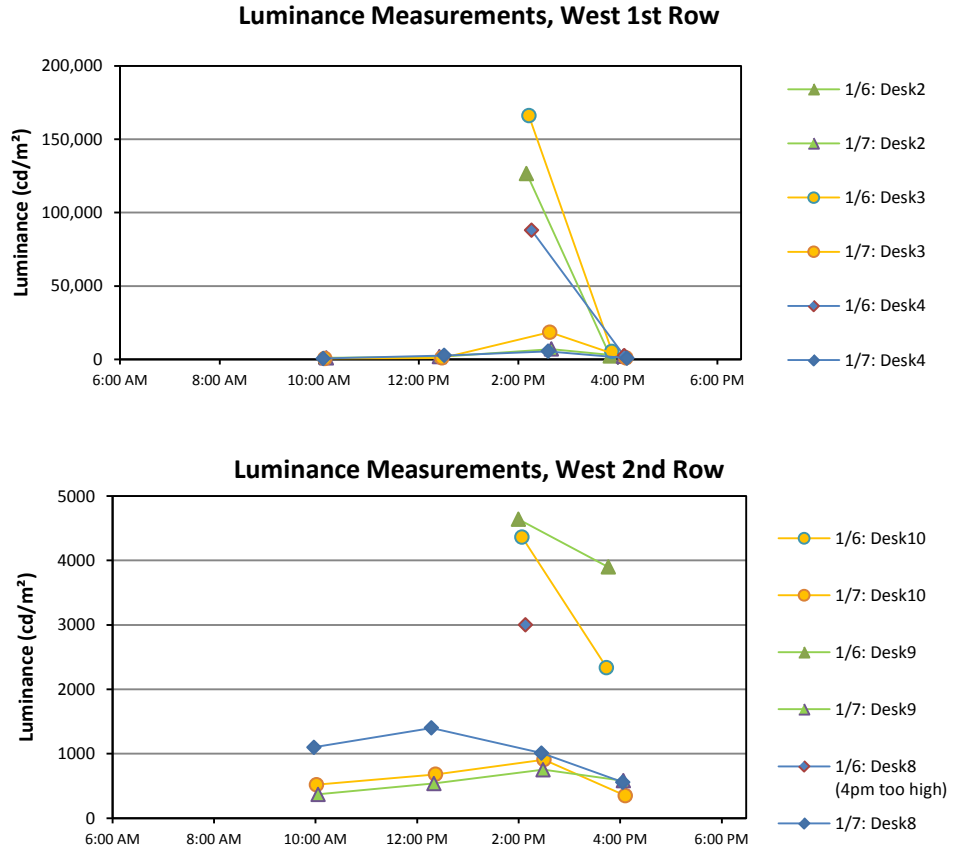
As shown in Appendix C and Figure 12 below, the desks in the first row on the west side had peak window luminances on the sunny afternoon. Luminance is a photometric measurement that is most closely related to perceived brightness (it is important to note that luminance and brightness are different, but since there are no meters that measure brightness, luminance is used as a surrogate). These occupants work with their backs to the window wall, thus face diagonally northeast rather than west. On the second row of western desks, luminance at 4 p.m. was too high for the meter measure (> 49,990 cd/m²) at Desk 8. Desks 9 and 10 had similar luminances as the south center desk with the blackout shades retracted (around 4000 cd/m²). Desks in the second row face the western window wall, and most of these desks are vacant; no complaints of window glare were registered in the questionnaire.

Figure 12. (A, top) Luminance measurements: west desks, first row. (B, bottom) Luminance measurements: west desks, second row.

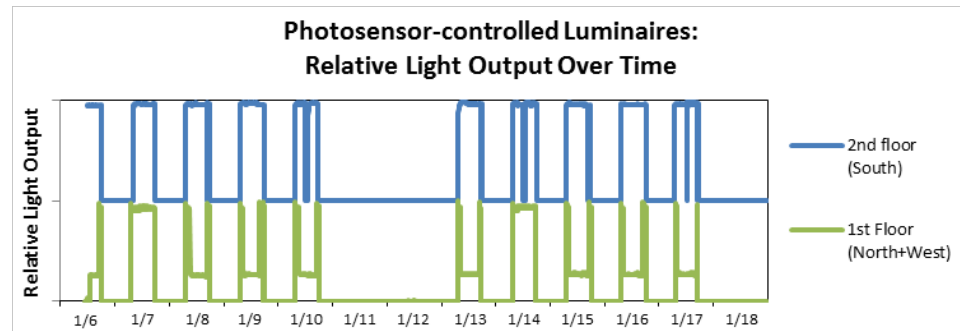
The data indicate that the electric lights operated at full output all day during the cloudy day when most of the measurements were taken (1/7/14). As shown below, the photosensors do, in fact, dim the lights on sunnier days, but only in the north and west control zones. On the south side of the building (where the window shades are commonly down), it appears that the sensors did not see sufficient light to trigger reduced electric light output. This was the case for the January monitoring period; dimming may occur in other months or sky conditions. According to Mr. Sielcken, the lighting controls system was confirmed to be working just a few weeks before this visit.

Figure 14. Photosensor-controlled luminaires: relative light output over time.

In the north and west control zones, the rows of lights closest to the windows appear to step down to about 25% of full output on sunny days. The electric light output in these zones did not appear to be continuously variable throughout the day. It should be noted that the photosensors were placed on the ceiling and aimed downwards. They measured the amount of light reflected off desktops.

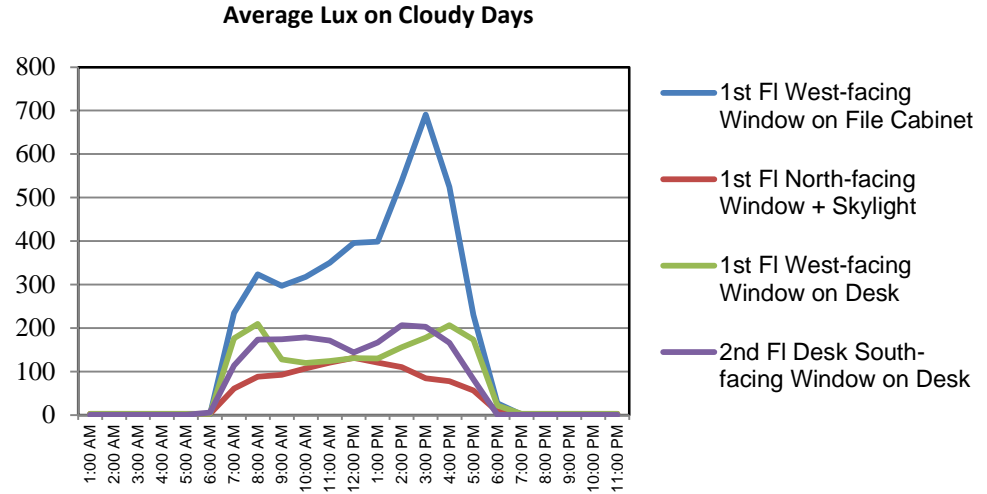
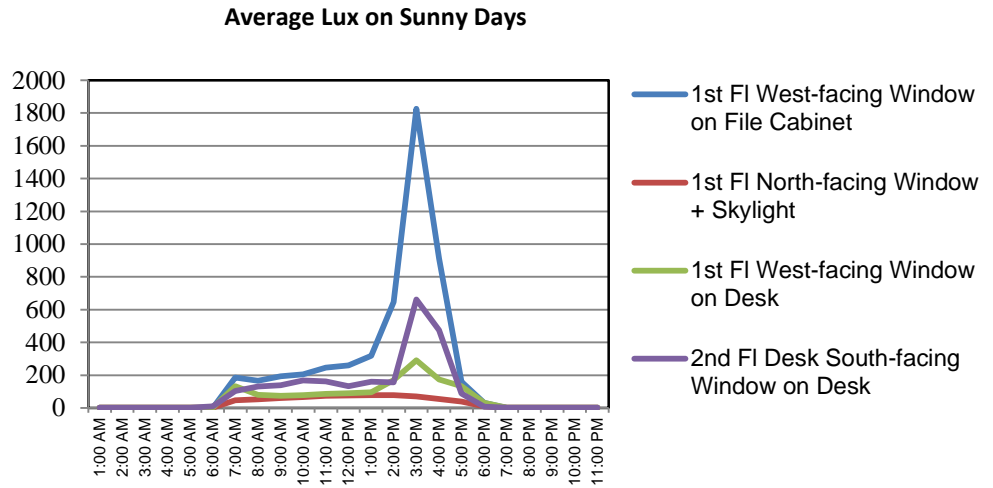
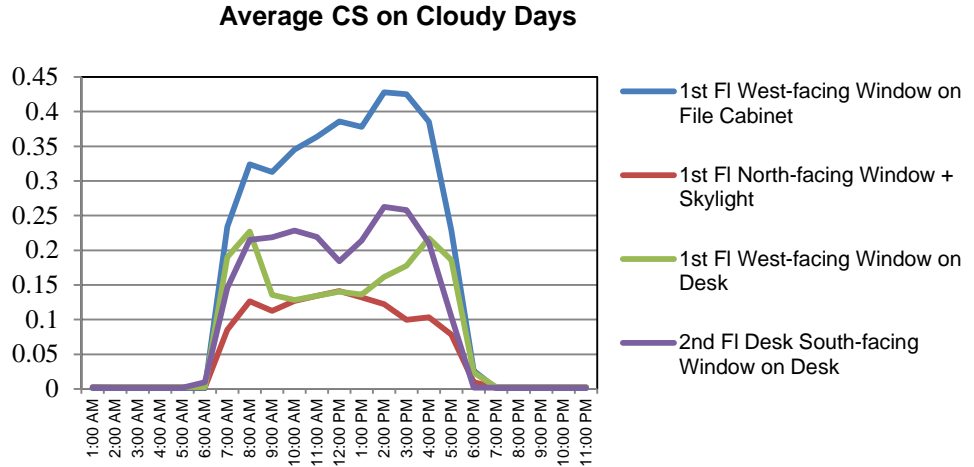
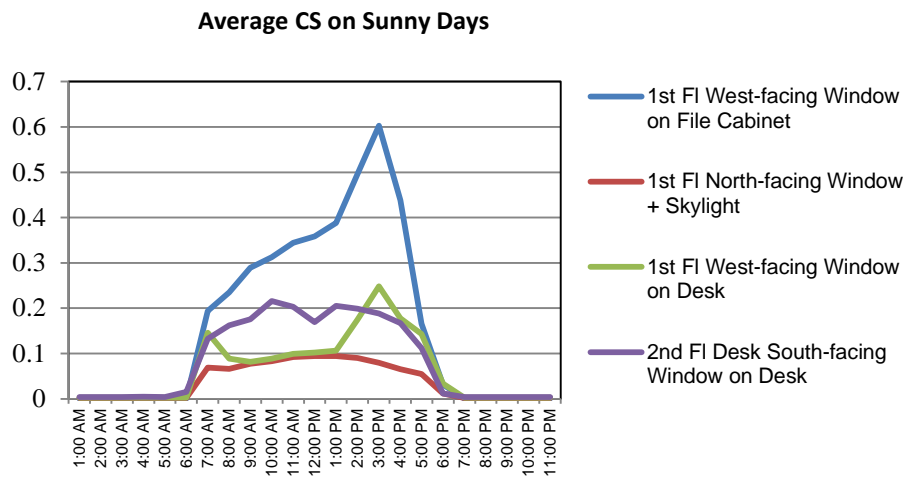
As shown in Figures 19-22, desks at north- and south-facing windows receive uniform light levels over the course of the day, while west-facing desk spaces tend to have a spike in light levels during the middle to late afternoon. South-facing window desk spaces receive more light during the day, most likely because the blackout shade was retracted, and the desk surface is close to the window, without cubicle wall obstructions. Given that these desk spaces were not occupied, it is not known whether the user of these desk spaces would pull the shades where there is sun (south and west facing), so these spikes/higher light levels would not be observed.

It is interesting to note, however, that except for the device that was placed on top of a file cabinet, all other devices recorded light levels at the eye that are consistent with desk spaces that do not have access to daylight. In other words, the desk spaces located in the

second row provide light levels below 200 lux at the eye. In terms of circadian stimulation, again, except for the device placed on top of the cabinet, CS values were below 0.2, which predicts 20% acute melatonin suppression after 1 hour exposure. The daylight contribution does not seem to significantly affect CS values, most likely because the desk spaces we used are farther from the window. While window shade positions may have played a role, it is unlikely that it would have influenced light levels reaching the desk spaces located farther from windows. Figure 23 below shows the relationship of CS and acute melatonin suppression, a marker of activation of the circadian system. Using data from various published studies, the LRC proposed the transfer function between circadian light and acute melatonin suppression shown below. According to this function, the circadian system will not respond to light below 30 lux (either incandescent or daylight) at the cornea, while any light above 1000 lux (i.e., spectrum does not matter in this case) will be at saturation. As shown in the graph in Figure 23, for the same lux levels, daylight is a slightly stronger stimulus for the circadian system than incandescent lamps mainly because it is rich in short-wavelength (blue) light.
