RESULTS REPORT:
FACILITY LIGHTING — WINTER
FEDERAL CENTER SOUTH
SEATTLE, WASHINGTON

Lighting Research Center
Rensselaer Polytechnic Institute

SUBMITTED MARCH 31, 2014

V2: REVISED/UPDATED MAY 18, 2016

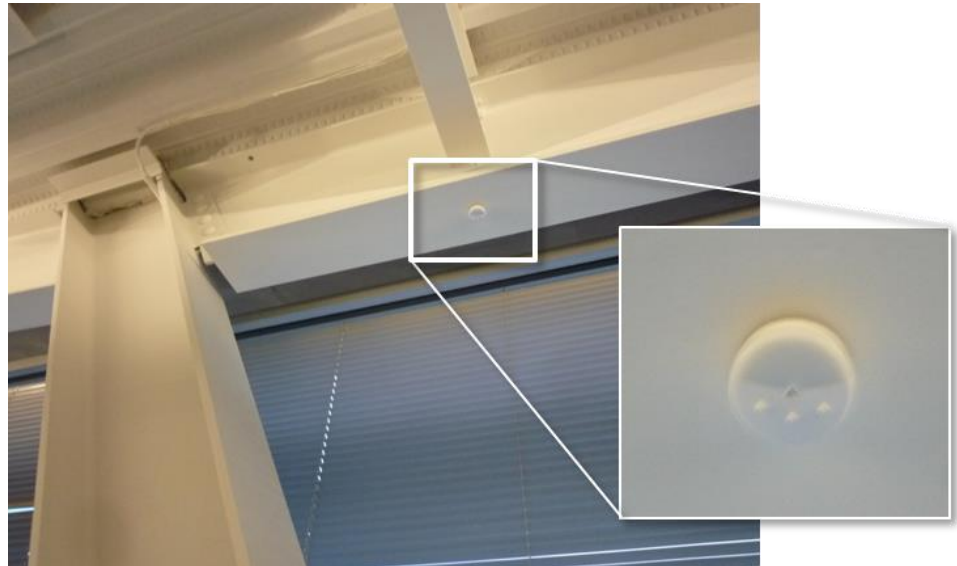
Lighting in open offices was designed with a daylight harvesting system that includes battery-powered wireless photosensors (Figure 2) and dimming ballasts in linear fluorescent luminaires.

Figure 2. Wireless photosensor.

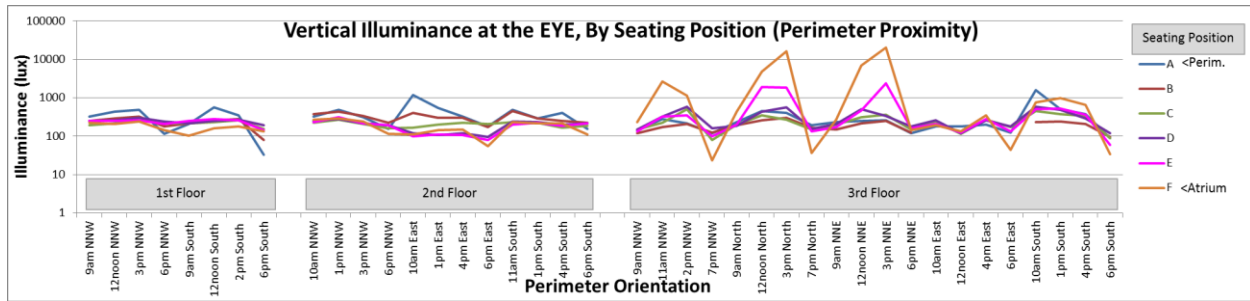
The results showed that the highest light levels on the cabinet occurred at the perimeter locations and the third floor desks with the atrium to the south. Highest light levels were also occurring in the middle of the day (Figure 9).

Figure 9. Vertical illuminance at the eye.

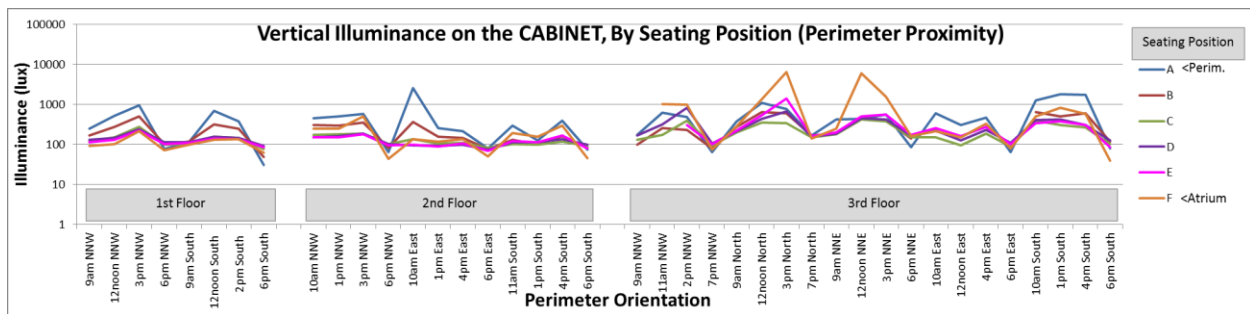
As shown in Figure 10, similar results were found for vertical illuminances at the cabinet. The Discussion section will introduce further analysis of circadian stimulation and glare using these data.

Figure 10. Vertical illuminance on the cabinet.

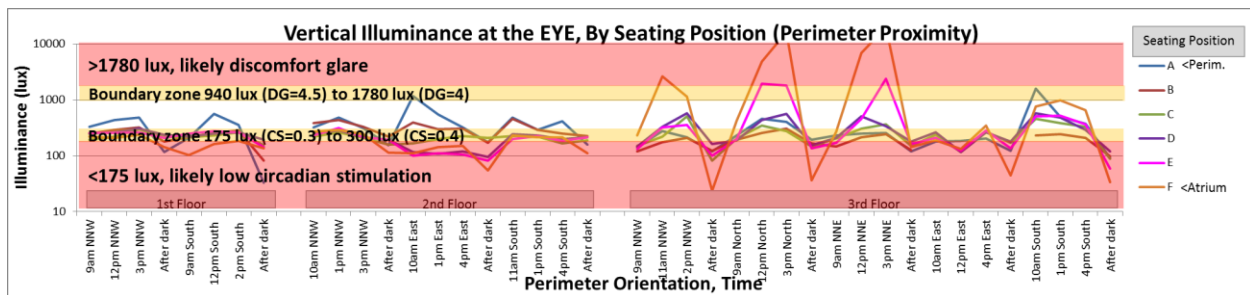
A summary of the findings is shown in Figure 14. Pink-shaded portions of the figure reflect areas likely to cause discomfort glare (DG), above 1780 lx, or likely to provide low circadian stimulation (CS), below 175 lx, for a daylight source. The yellow-shaded boundary, between 940 lx and 1780 lx, is considered at or near threshold for evoking a discomfort glare response from occupants. The lower end of the threshold boundary for discomfort glare represents a DG rating of 4.5 whereas the upper boundary represents a DG rating of 4.0. The blue-shaded boundary, between 175 lx and 300 lx, is considered to be at or near threshold for reliable stimulation of the human circadian system. The lower end of the threshold boundary for circadian stimulation represents a CS value of 0.3 whereas the upper boundary represents a CS value of 0.4.

Figure 14. Vertical illuminance at the eye in different work stations at different times of day. The photopic sensor making measurements was oriented so that it faced the work station computer screen at a common eye height. Consequently, as a result of the work-station layout, all illuminance measurements were made with the sensor facing the atrium.

Relative visual performance (RVP), or the speed and accuracy of reading, will be high ($RVP > 0.95$) for all conditions, because the computer monitors provide high contrast/large font size and any printed materials will be illuminated to at least 300 lx on the desk surface (horizontal illuminance).

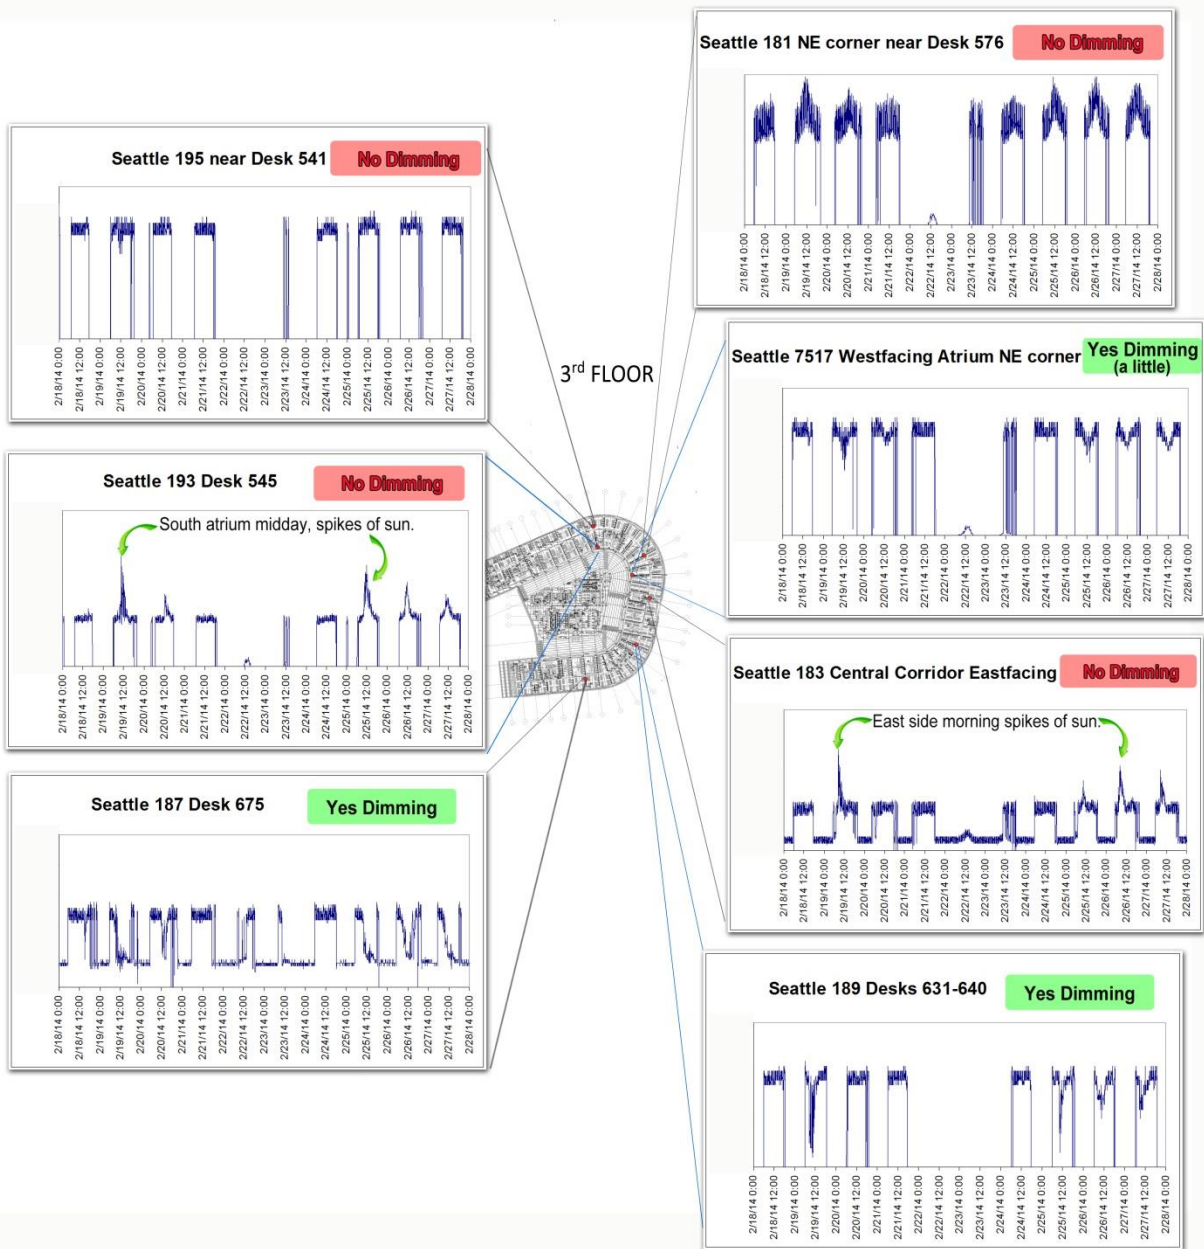
Figure 19. Third floor luminaire monitoring results over the course of one week.

- Some of the luminaires on the third floor, where there is daylight availability, did not appear to dim in response to daylight. Luminaires on the first and second floors were dimmed, perhaps contributing to the low levels observed on these two floors.

The reason why dimming did not occur at some of these luminaires may not be problematic; it is possible that the sensors are working as intended, and simply did not “see” enough light during the winter evaluation to justify dimming down the lights. Dimming may become more prevalent if luminaires are re-monitored in the summertime.

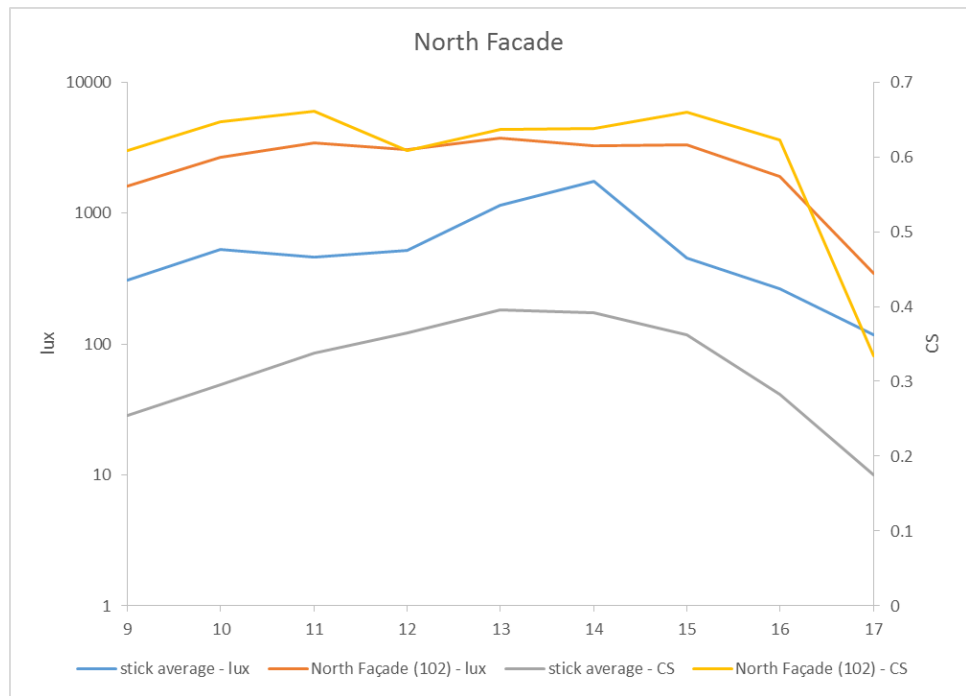
Figures 20-23 show the photopic lux and CS values for the Daysimeter measurements placed on desks located on the north, east and south/southeast facades, together with the photopic lux and CS values for the Daysimeter placed on windows. It is interesting to note that the ratio between window photopic illuminance measurements and deskpace illuminance measurements is the lowest on the north side of the building and the highest (10 times more) on the south/southeast side of the building. This difference is most likely due to shade use and sunlight hitting the south/southeast façade. We were not able to place a window unit on the skylight at the atrium; therefore, the unit was located indoors, close to the deskspaces, and as expected, the ratio between the window unit and the deskpace units was much smaller (2.2). This is shown in Figure 23.

Figure 20. Average photopic lux and CS values for the Daysimeter placed at deskspaces located on the north side of the building over the course of the working day (08:00 am to 05:00 pm). Photopic light levels indoors are reduced by about a factor of 5 compared to those on the north façade.

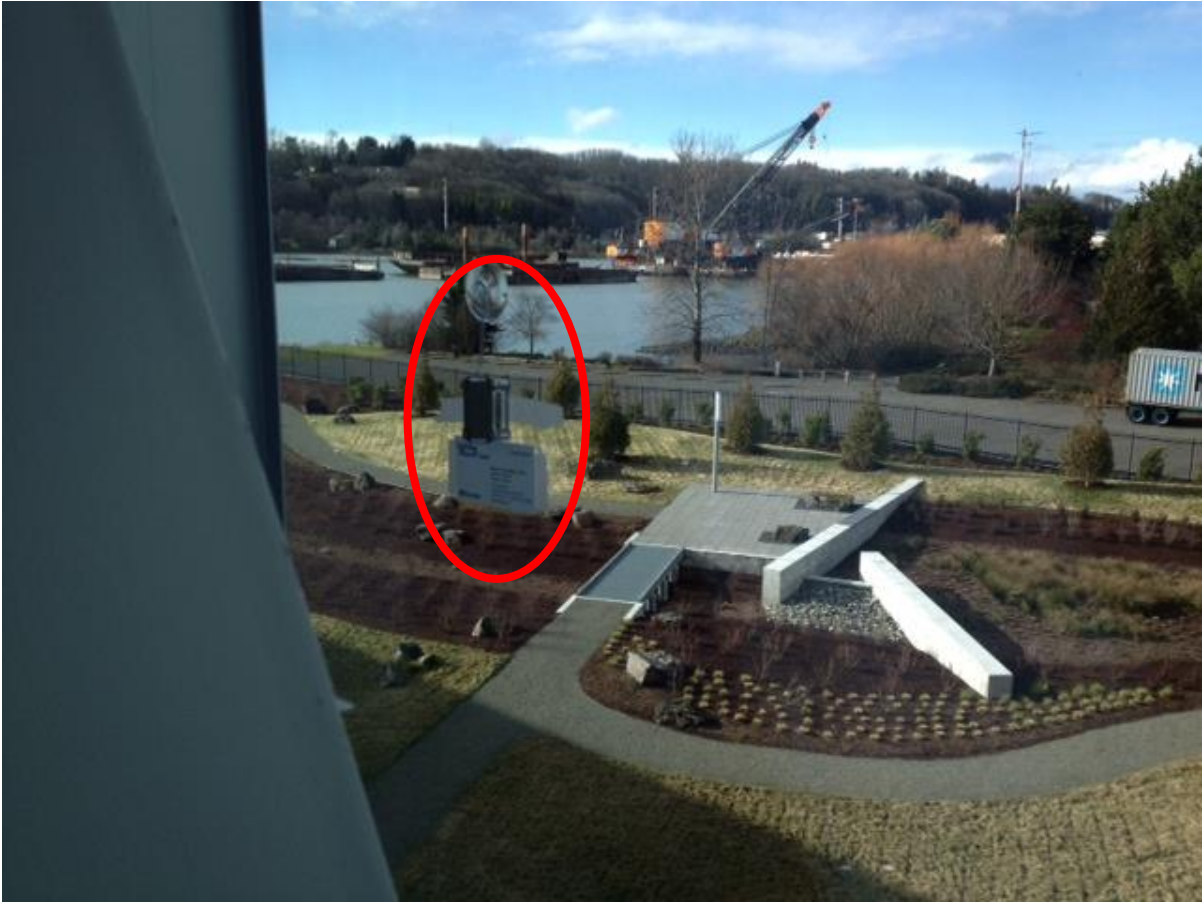
WINDOW UNIT 102

14:32, Daysimeter unit 102, attached by suction cup to window, facing outward

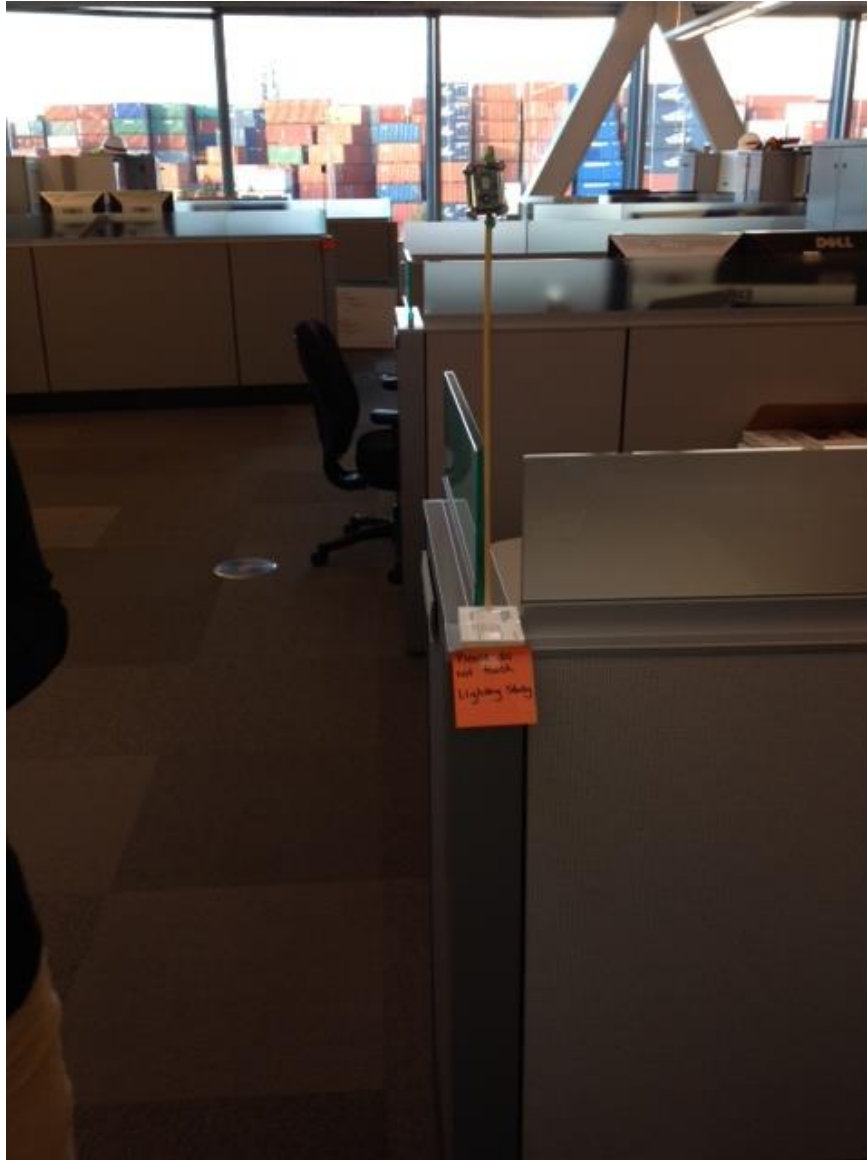
DESK 543

16:35, Desk 543

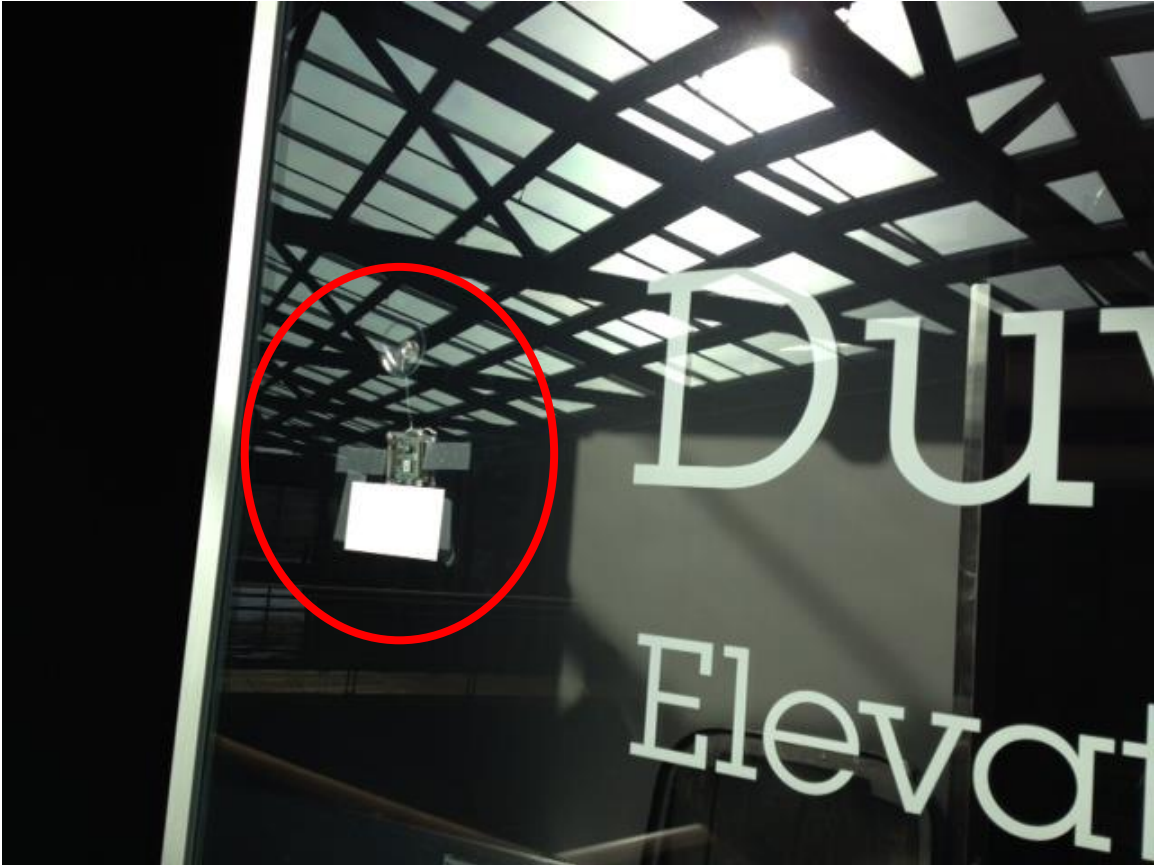
WINDOW UNIT 101

14:30, Window 101, attached by suction cup, facing into atrium

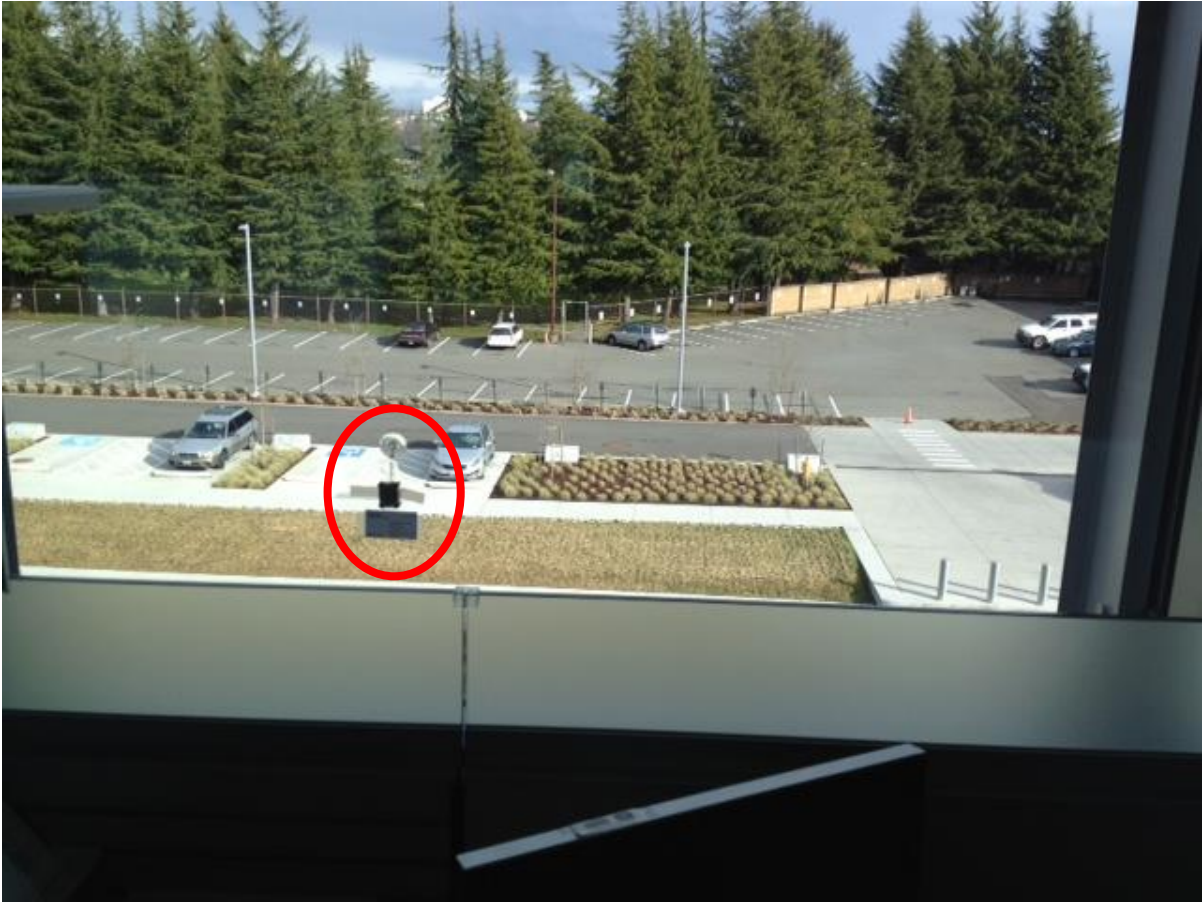
WINDOW UNIT 103

14:30, Window unit 103, attached by suction cup, facing outward

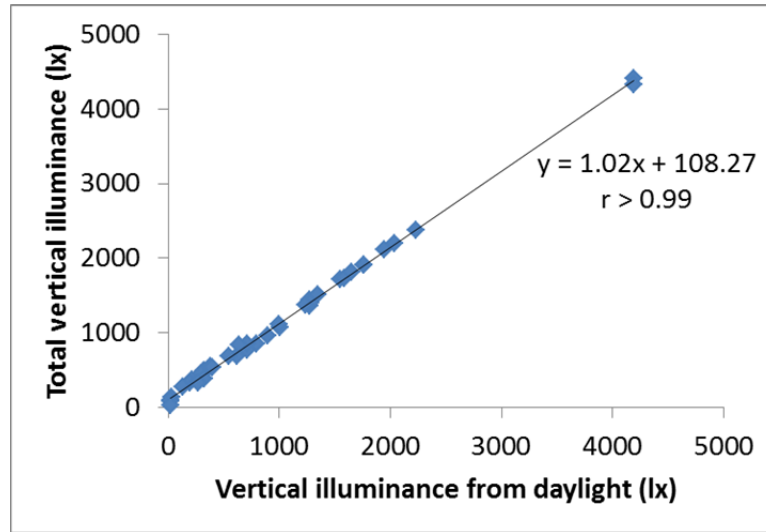
Figure 1 shows the relationship between the total vertical illuminances (including contributions from both daylight and electric light) and the daylight-only vertical illuminances for each trial. There is a very strong correlation ($r > 0.99$, $p < 0.05$) between the two sets of values; primarily this is because the vertical illuminance from the electric lighting was usually relatively small (100-200 lx) compared to the illuminance from the windows (up to nearly 4500 lx).

Figure 1. Relationship between total vertical illuminance and daylight-only vertical illuminance at the observers' eye position.

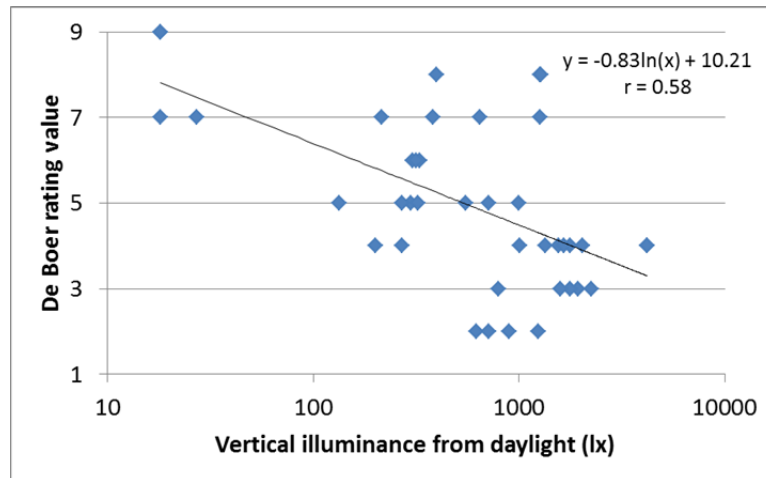
Figure 2 shows the discomfort glare ratings plotted as a function of the vertical illuminance from daylight for each of the individual observations. There is a moderate and statistically significant ($r = 0.58$, $p < 0.05$) but negative correlation between the sets of values, but as seen in Figure 2 there can be substantial variation among ratings for conditions with similar vertical illuminances from daylight.

Figure 2. Individual discomfort ratings, plotted as a function of the vertical illuminance from daylight at each observation.

A within-subjects analysis of variance (ANOVA) was conducted on the ratings using the blinds position (open or partially closed) and the electric light level setting (full or half) as independent variables. There were statistically reliable ($p < 0.05$) main effects for both variables, with ratings being numerically higher (less glare) for the partially closed blinds setting and for the higher electric lighting level. The interaction between blinds position and electric lighting level on the glare ratings was not statistically reliable ($p > 0.05$).

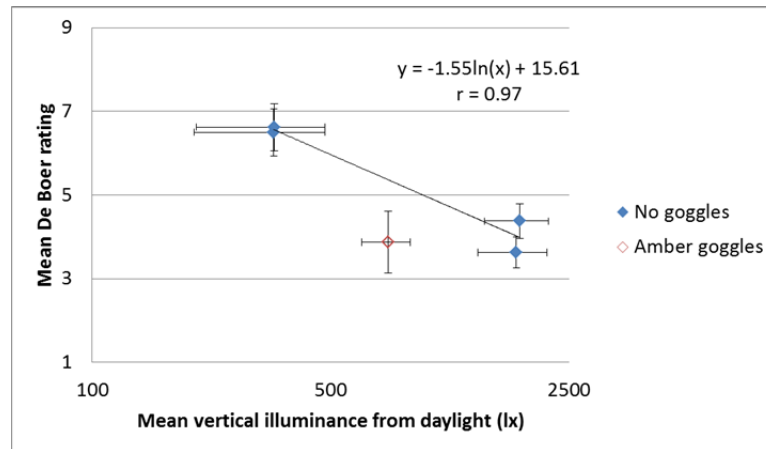
Figure 3 shows the mean ratings for each combination of blinds position and electric lighting level, plotted as a function of the mean illuminance from daylight for each condition. The data closely follow a logarithmic function of vertical illuminance with a strong, statistically significant correlation ($r = 0.97$, $p < 0.05$) between

the mean illuminance values and the mean ratings. Also shown in Figure 3 is the mean vertical illuminance and glare rating value for the blinds-open, half-electric-lighting condition, when viewed through the orange goggles.

Figure 3. Mean discomfort ratings for each blinds and electric lighting condition, plotted as a function of the mean vertical daylight illuminance from each condition. Also shown is the mean rating to the blinds-open, half-electric-lighting level when wearing orange goggles.

Of interest, it can be seen that when observers wore the orange goggles, the mean discomfort glare rating value decreased (indicating increased discomfort) relative to the predicted value estimated based on illuminance without the goggles. Perceptions of discomfort glare and brightness are influenced by the spectral content of illumination (Bullough 2009; Rea et al. 2011; Bullough et al. 2014). Kelly (1990) and Perez et al. (2003) found amber lenses to increase brightness perception of a scene; and although Bullough et al. (2009) would have predicted lower discomfort glare with the orange goggles, observers may have been judging their sensations of glare in part by the perceived brightness of the overall scene. Daylight is variable in both intensity and spectral content, so understanding the role of spectral content in discomfort glare could be helpful in planning daylighted environments in the future.
