RESULTS REPORT:

FACILITY LIGHTING — WINTER

WAYNE N. ASPINALL FEDERAL BUILDING
GRAND JUNCTION, COLORADO

Lighting Research Center
Rensselaer Polytechnic Institute

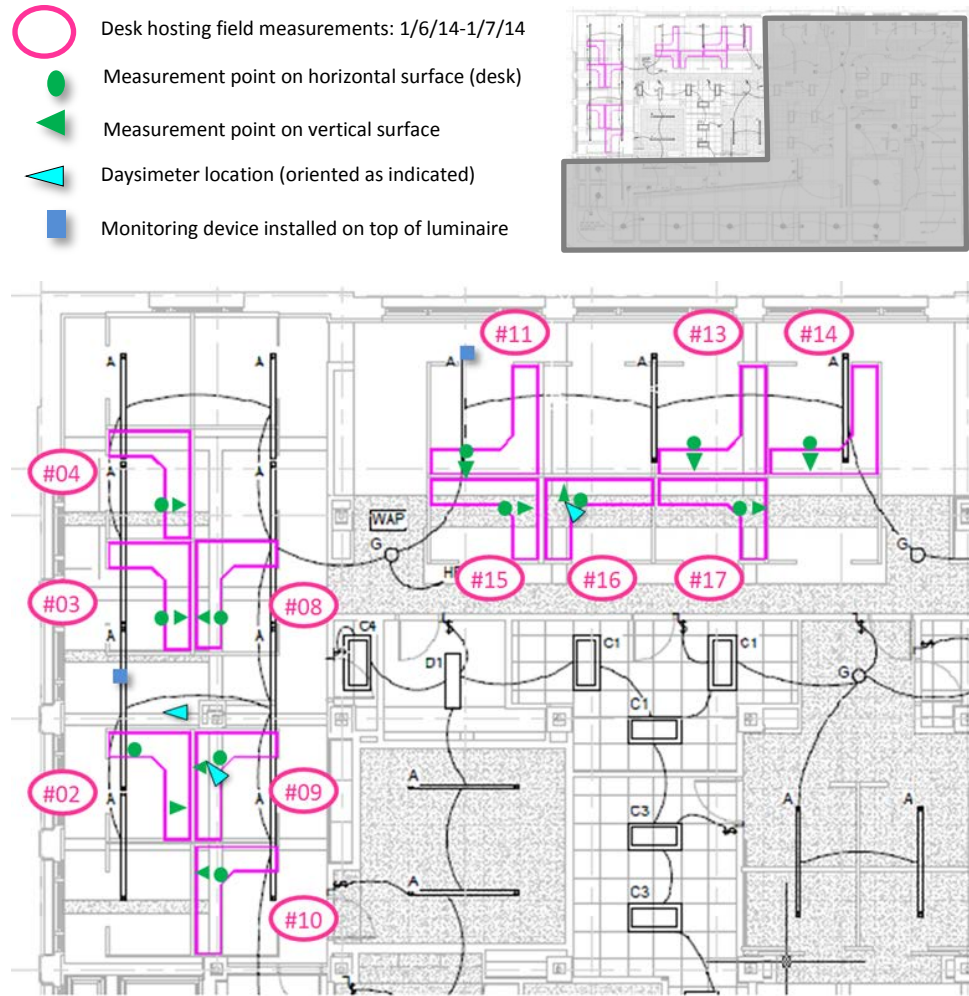
Figure 1. First floor measurement locations: north and west orientations.

On the north second row desks, horizontal illuminances were low [40-220 lux (4-20 fc)] throughout the measurement day. It should be noted that these second row desks do not have electric lighting overhead due to a large skylight that does not receive direct sun due to its location behind the protruding second and third floors. Vertical illuminances were equivalently low [30-170 lux (3-16 fc)]. If these desks eventually become occupied, task lighting will be necessary and energy use will increase (though not necessarily to a substantial extent).

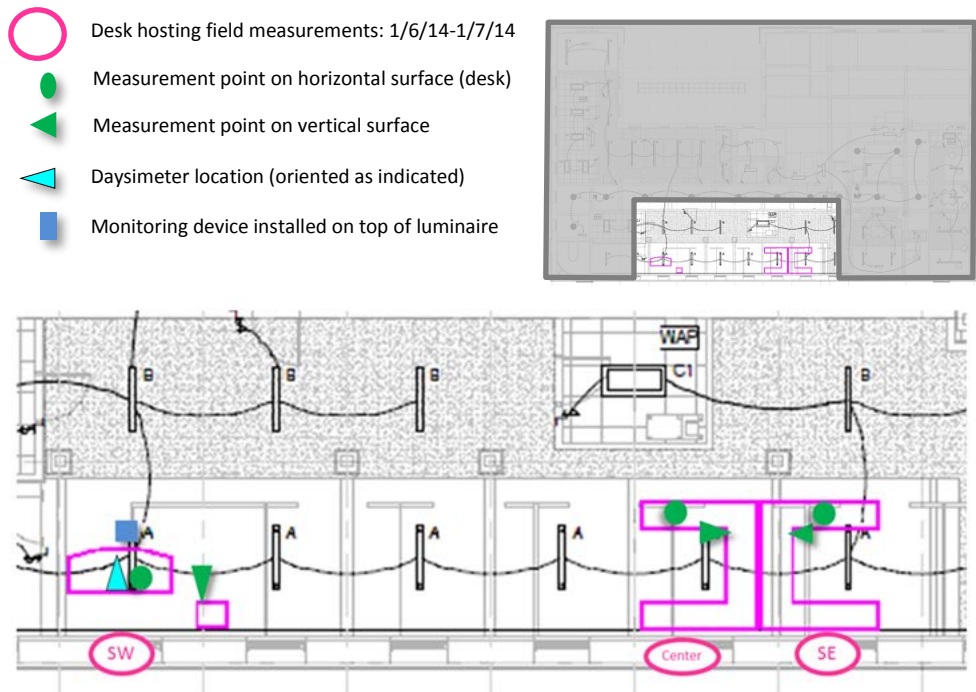
Figure 3. Second floor measurement locations: south orientation.

For these south-facing windows, personnel have the option of using the (translucent) black mesh shades, as well as opaque blackout shades (Figure 4). Electric lighting appears to be the same fluorescent pendants as on the first floor. As shown in Appendix D, one sensor sends a signal to all the luminaires in the space; although the right window in Figure 4b has blackout shades retracted, subsequent sun may not be “seen” by the sensor.

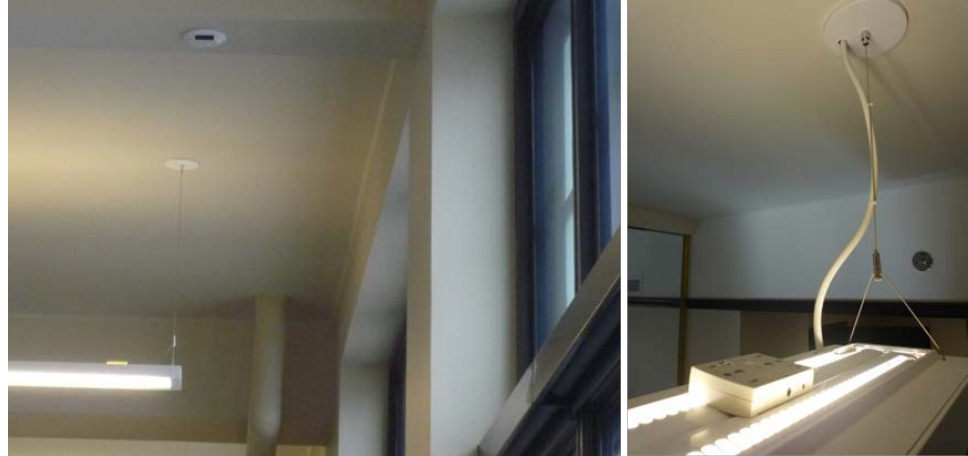
Figure 13. (A, left) Battery-powered light meters were installed in two locations on the first floor, and one location on the second floor. (B, right) A close-up of the sensor measuring light passing through uplight slots.

In the north and west control zones, the rows of lights closest to the windows appear to step down to about 25% of full output on sunny days. The electric light output in these zones did not appear to be continuously variable throughout the day. It should be noted that the photosensors were placed on the ceiling and aimed downwards. They measured the amount of light reflected off desktops.

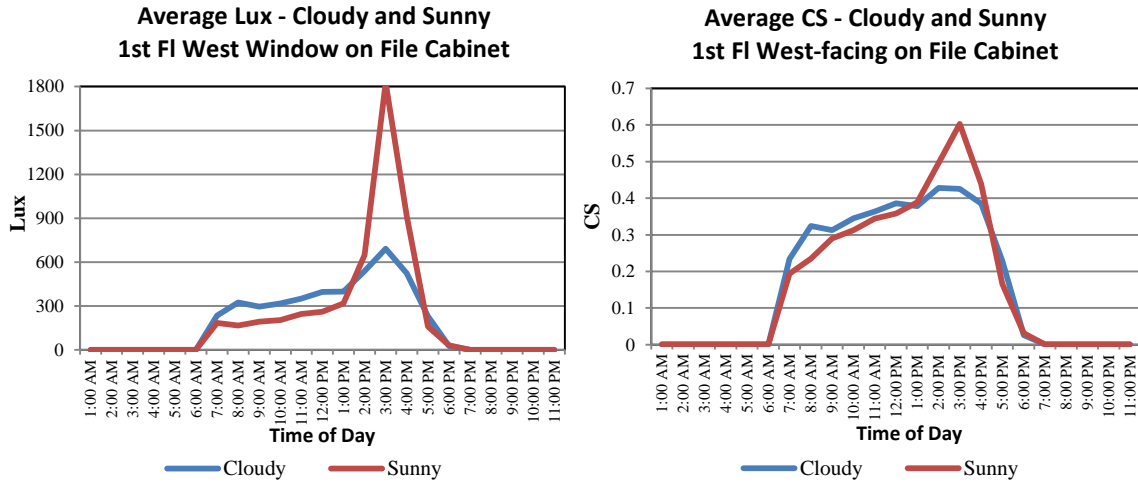
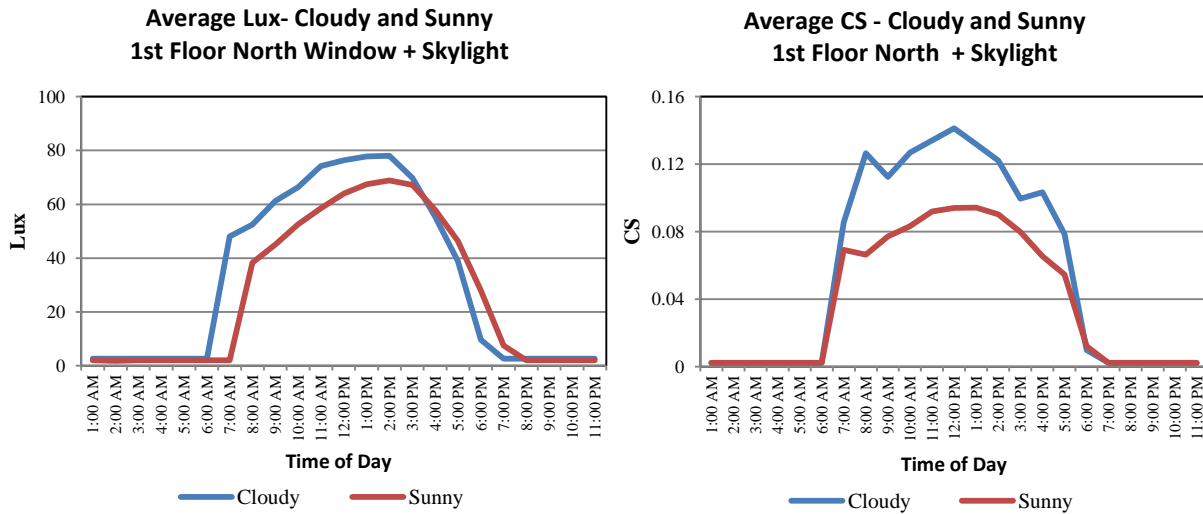
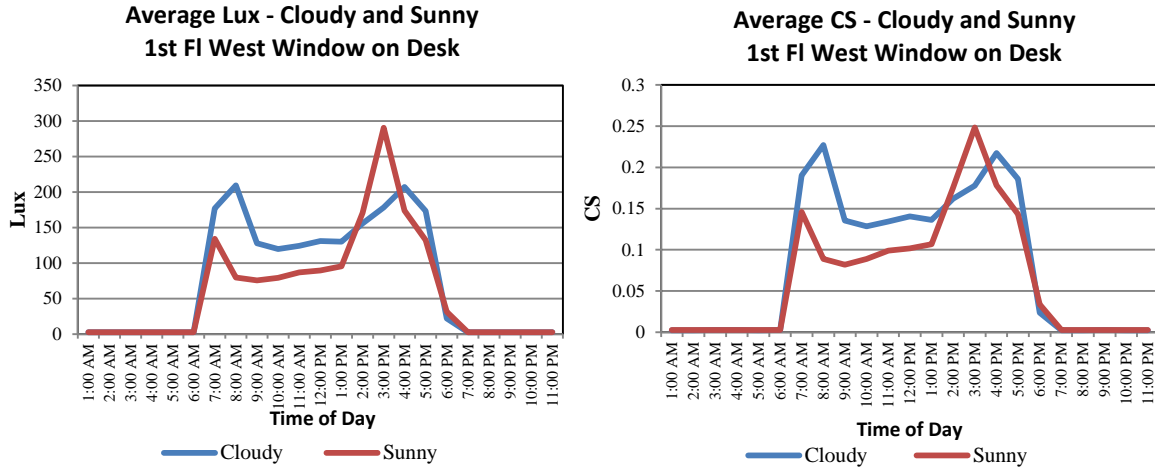
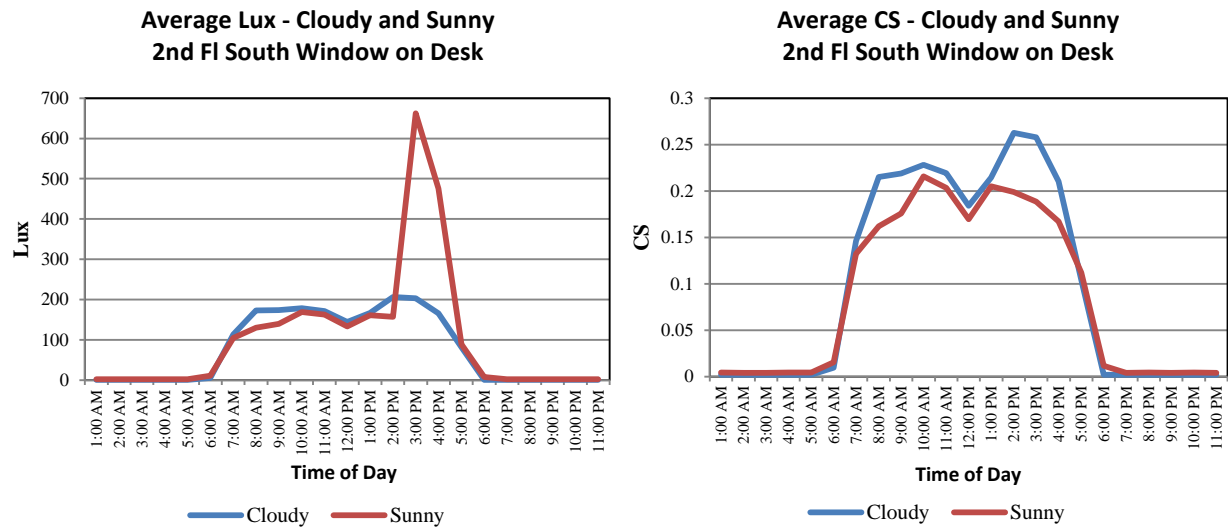
It is interesting to note, however, that except for the device that was placed on top of a file cabinet, all other devices recorded light levels at the eye that are consistent with desk spaces that do not have access to daylight. In other words, the desk spaces located in the

second row provide light levels below 200 lux at the eye. In terms of circadian stimulation, again, except for the device placed on top of the cabinet, CS values were below 0.2, which predicts 20% acute melatonin suppression after 1 hour exposure. The daylight contribution does not seem to significantly affect CS values, most likely because the desk spaces we used are farther from the window. While window shade positions may have played a role, it is unlikely that it would have influenced light levels reaching the desk spaces located farther from windows. Figure 23 below shows the relationship of CS and acute melatonin suppression, a marker of activation of the circadian system. Using data from various published studies, the LRC proposed the transfer function between circadian light and acute melatonin suppression shown below. According to this function, the circadian system will not respond to light below 30 lux (either incandescent or daylight) at the cornea, while any light above 1000 lux (i.e., spectrum does not matter in this case) will be at saturation. As shown in the graph in Figure 23, for the same lux levels, daylight is a slightly stronger stimulus for the circadian system than incandescent lamps mainly because it is rich in short-wavelength (blue) light.

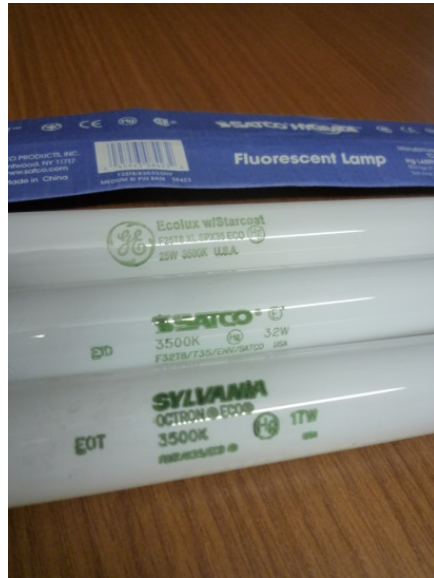
There were no reports of widespread premature lamp failures. Mr. Gasperini produced samples of the T8 linear fluorescent lamps in use in the building: 3500K, 70-80⁺ CRI, as shown in Figure 32.

Figure 32. Sample fluorescent lamps.
